NPDES Permit Number: MAR10D585

Project Name: **Route 62 Roadway Resurfacing and Reconstruction**
Project Address: Route 62 Concord, Massachusetts
Project Proponent: **Town of Concord Public Works/ MHD**
Report Prepared By: Mary Trudeau, Environmental Consultant
Date of Report/Site Visit: November 20, 2009

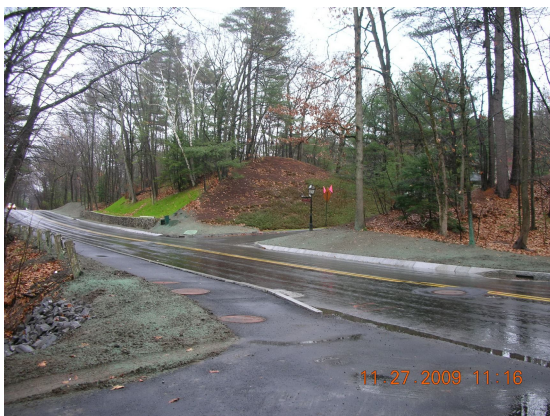
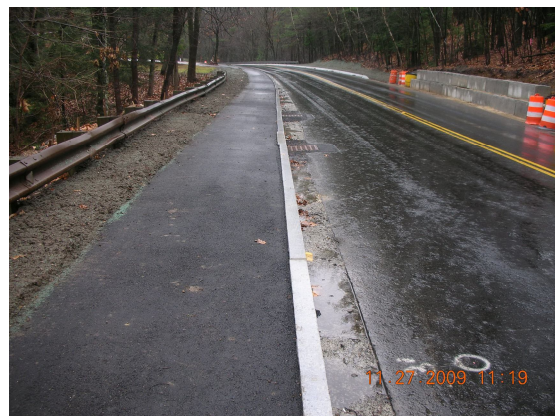
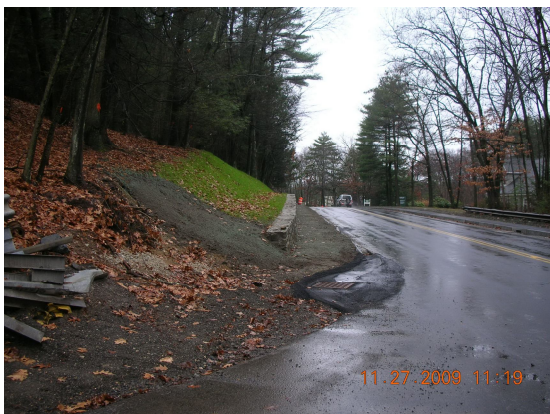
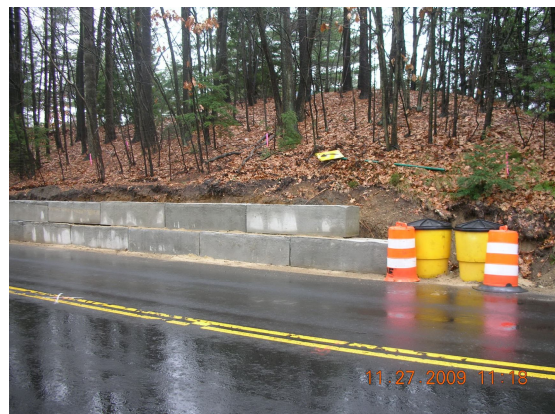
Work within the locus is largely completed for the season, with work expected to resume in the spring of 2010. To that end, the contractor has initiated slope stabilization work throughout the work area, and has completed much of the drainage outfall and wall work noted in earlier reports. The following photos show some of the work that has been done in recent weeks to stabilize the site:

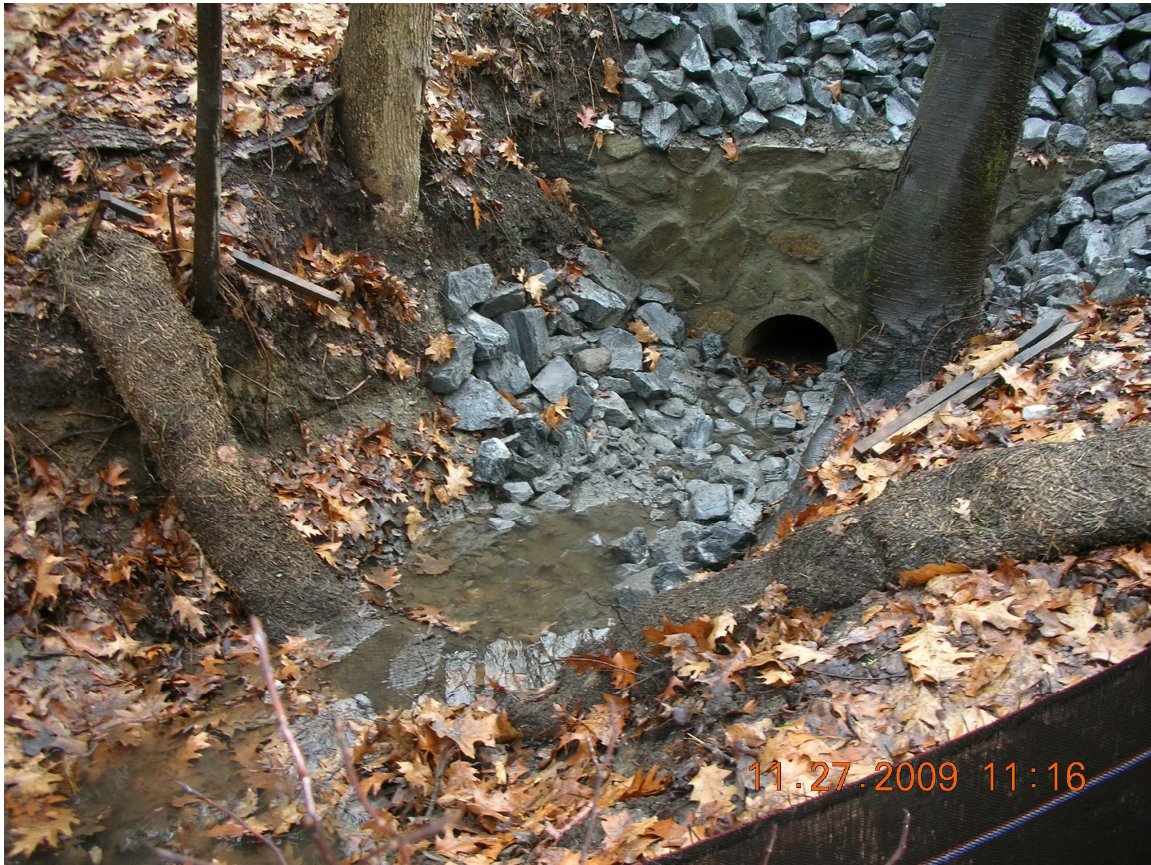
As noted in past reports, I had concerns with the condition of the stormwater outfall, located on the north side of Route 62, at station point 23+25. The following photo shows the condition of this area at my most recent site visit and the relatively clear stormwater

flows viewed on November 27, 2009. The photo shows the stabilized slope above the outfall, as well as the rip rap placed at the mouth of the outfall pipe.

As noted in past reports, the contractor should restore the downgradient erosion and sedimentation controls, in this location, by replacing the torn and damaged silt filter fabric fencing and by replacing the straw wattle with a new wattle or straw bales. I spoke with Alan Visco on November 20, 2009 and reminded him that this would be a good use for his stockpile of erosion controls.

1. The contractor should rebuild the erosion controls below the headwall at station point 23+25 on the north side of Route 62. The area above the outfall has been nicely stabilized, but adding controls below the outfall should be done before leaving the site this fall.
2. The contractor should address the sedimentation that has occurred down gradient of the drainage outfall at the north side of Route 62 at station point 15+00. Raking and hand work is the appropriate remediation.

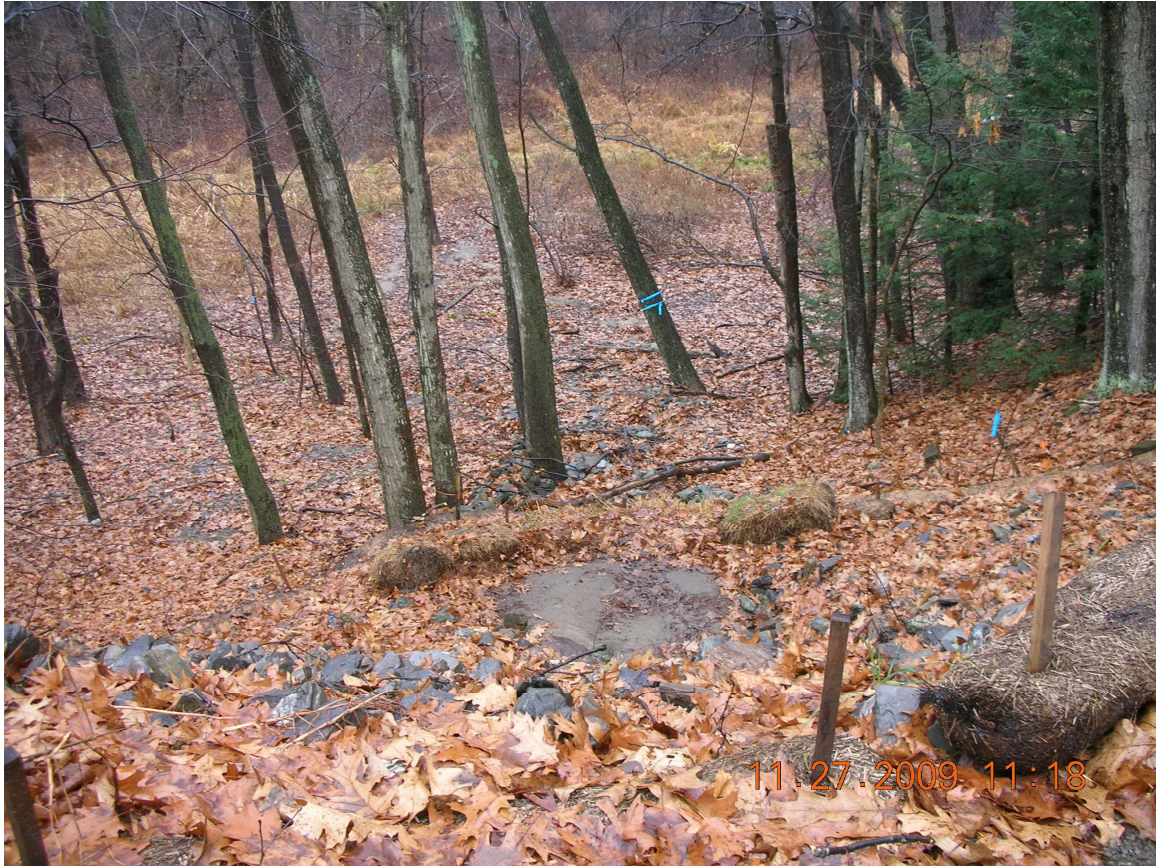
While I continue to recommend remediation of the areas below the outfall at station point 15+00, on the north side of Route 62, the flows from the outfall appear to be largely free of sediment. With current pavement grading, the outfall does not appear to be receiving flows from catch basins, but as noted in earlier reports, there has been some historic discharge of sediment to down gradient buffer zone and wetland resource areas. While the accumulations are not significant, the contractor should send a laborer to rake and remove any deposits of material. The following photo shows this area:

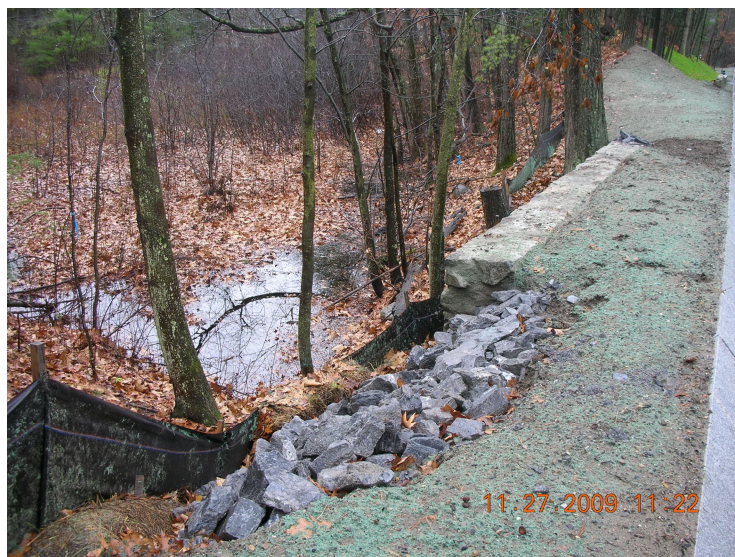
During the rain event of November 27, 2009, I inspected the newly completed detailing of the slope adjacent to either end of the easternmost retaining wall. This wall is located at approximately station point 27+50, on the south side of Route 62. At my site visit this week, I noted that the area appears stable and water within the downgradient wetland is clear and without evidence of sediment deposition:

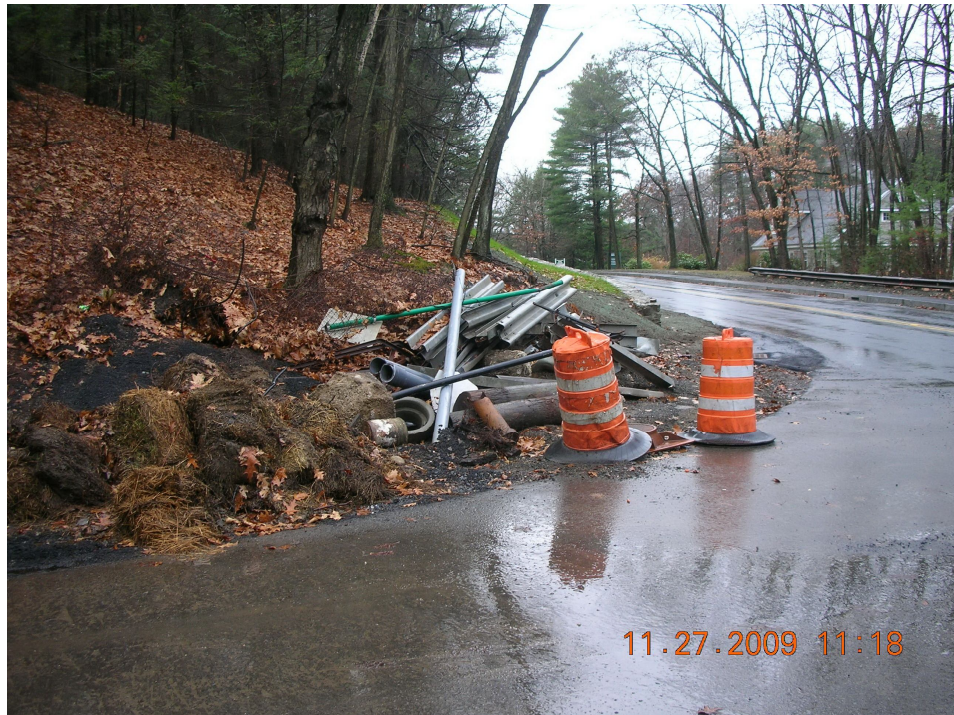
I did note that while much of the Route 62 locus is free of construction debris and materials, the contractor has a small stockpile of materials to be removed from the western corner of the Starmet Driveway. I am assuming that these materials will be removed from the locus in the near future.

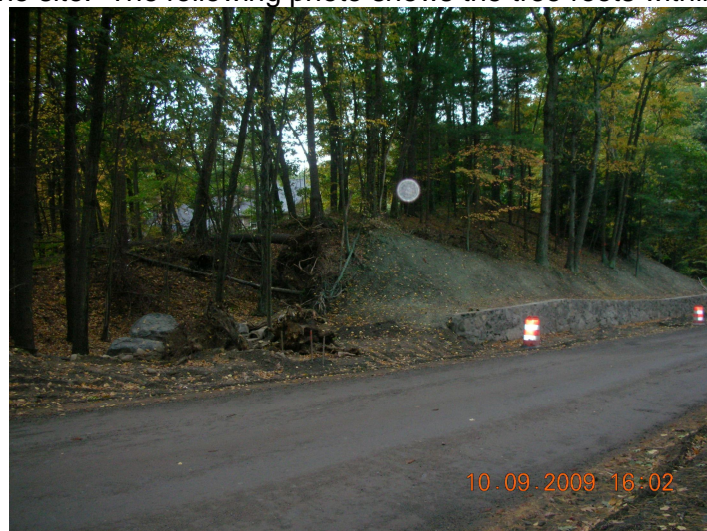
Also noted in earlier reports, Mrs. Sulewski, a condominium owner on Cranberry Lane noted that a tree fall at the south side of Route 62, at approximately station point 25+75 has fallen into and across her yard. Alan Visco and Minot Wood of EHPerkins Construction have determined that the tree fall is within forty feet of the centerline of the road (and is their responsibility) and that it will be cut and removed when the tree cutting crew returns to the site. The following photo shows the tree roots within the job locus:

The contractor has noted that the remaining tree removal work has been postponed until spring of 2010.
